REPORT ON THE CAPSIZE OF THE PASSENGER VESSEL LADY D

FINAL REPORT

26 July 2004

John J. McMullen Associates, Inc.
4300 King Street, Suite 400
Alexandria, Virginia 22302

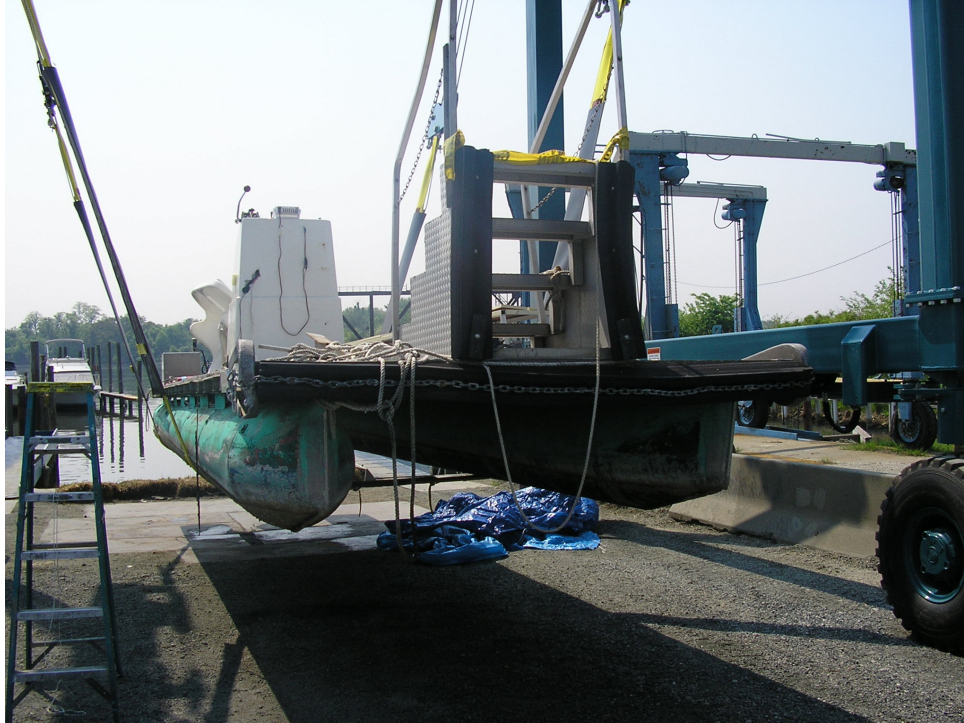
Figure 1 LADY D on May 11, 2004

While the vessel was in the travel lift, damage was noted to the starboard pontoon in the stern and further forward. Captain Narizzano noted that this damage was caused to the LADY D during rescue operations following the capsizing. Water was observed to be coming out of the starboard pontoon at the transom in way of the damage to the pontoon. The pontoons are constructed in sections with transverse bulkheads fitted between sections. The bow and the aftermost compartment are three feet long, and the middle sections are each six feet long. The overall length of the vessel is about 36 feet. An inspection was made of each section of both port and starboard pontoons to determine if there was water in any of the sections. This was done both visually and by tapping the pontoon and listening for a hollow sound. The only section that showed any evidence of water in it was the aftermost section of the starboard pontoon. Water was observed leaking out and it did not sound empty when tapped.

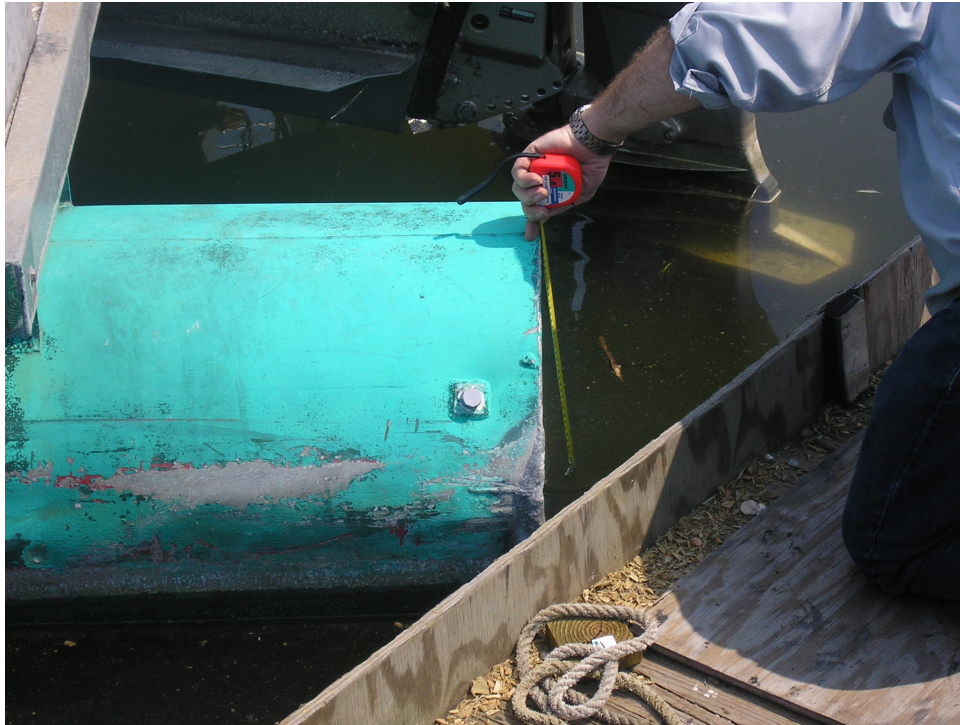
Figure 2 Freeboard Reading at Aft End of Port Pontoon

To drain all the water out of the pontoon prior to launching the vessel, a small hole was drilled in the bottom of the pontoon near the transom. The vessel was hanging in the slings of the travel lift with the stern lower than the bow. Water was allowed to drain from the pontoon until the flow stopped. The hole was then plugged with a screw and gasket, and the damaged areas of the pontoon were sealed with epoxy. Once the epoxy had set, the boat was launched and prepared for reading the freeboards. Freeboard readings were taken at the bow, amidships, and stern of the vessel on both port and starboard sides as illustrated in Figure 2. A measurement of freeboard of

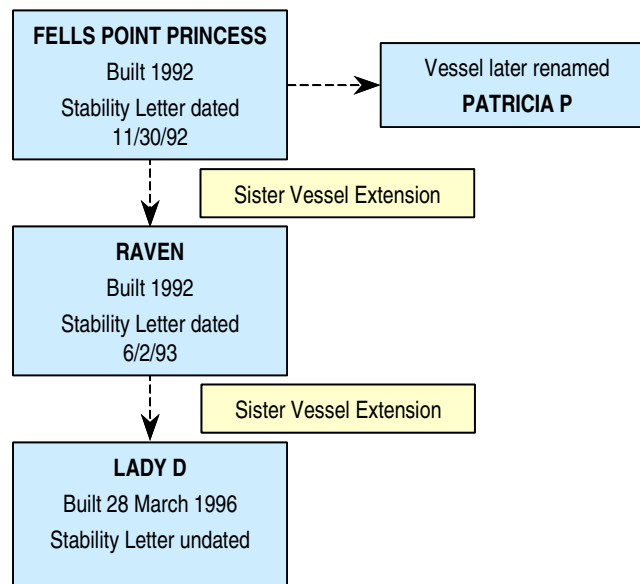
Figure 6 LADY D Stability Letter Heritage

- The LADY D was issued a stability letter based on her “sister” relationship to the RAVEN. RAVEN was granted her stability letter based on her “sister” relationship to the FELS POINT PRINCESS. That the LADY D was built beyond the 24-month window permitted by Coast Guard for defining a “sister” relationship should be sufficient by itself to question the validity of the stability letter granted by the Coast Guard. However, in this case there are a number of significant differences between the LADY D and her “sister” RAVEN that call into question why the “sister” relationship was considered at all.
- The stability test conducted on the FELS POINT PRINCESS, upon which both RAVEN and LADY D stability letters were granted, included several errors which made the FELS POINT PRINCESS look like she had much better stability than she actually did.

The stability letter granted to the LADY D is based on the stability letter of the RAVEN, which is in turn based on the stability letter of the FELLE POINT PRINCESS. The LADY D relied upon its sister vessel relationship with the RAVEN to receive its stability letter. Figure 6 illustrates the heritage of the LADY D stability letter.

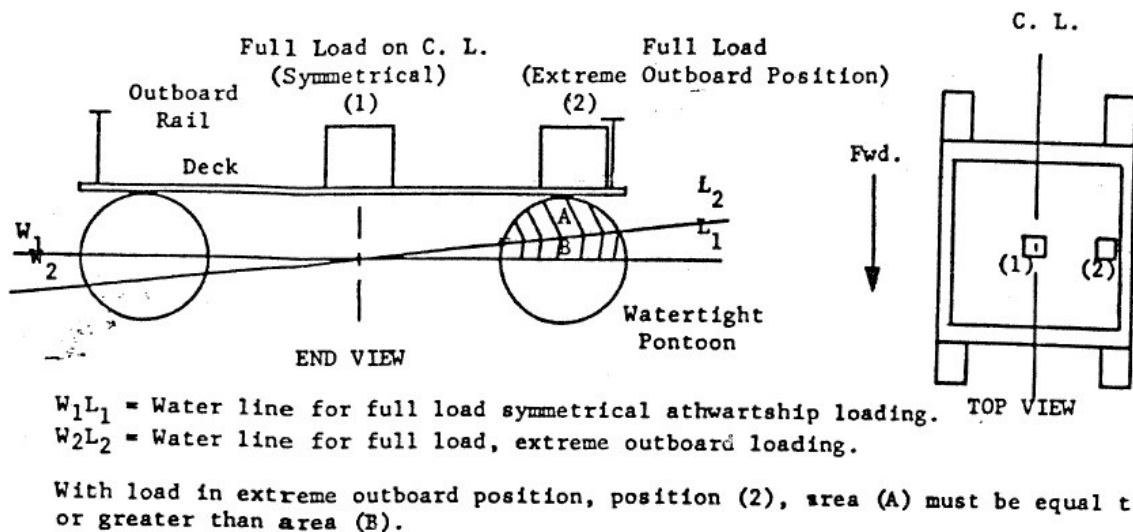
Figure 9 Marine Safety Manual Passenger Heeling moment Calculation

There appear to be two basic errors in the FELS POINT PRINCESS stability analysis. The first error is in the heeling moment used. In the stability calculations it appears that the heeling moment calculations were based on the 46CFR 171.030, while the stability criteria applied was based on that contained in the Marine Safety Manual. The mixing of two separate and distinct criteria, founded on two very different approaches resulted in a significantly reduced heeling moment applied in the stability calculations. On page 4 of Data Package #3 (which shows the calculation based on 46CFR 171.030), the passenger heeling moment was calculated as 4258 ft-lbs, and the wind heeling moment was calculated as 5352 ft-lbs. Heeling moment calculations from page 4 of Data Package #3 are provided in Figure 8.

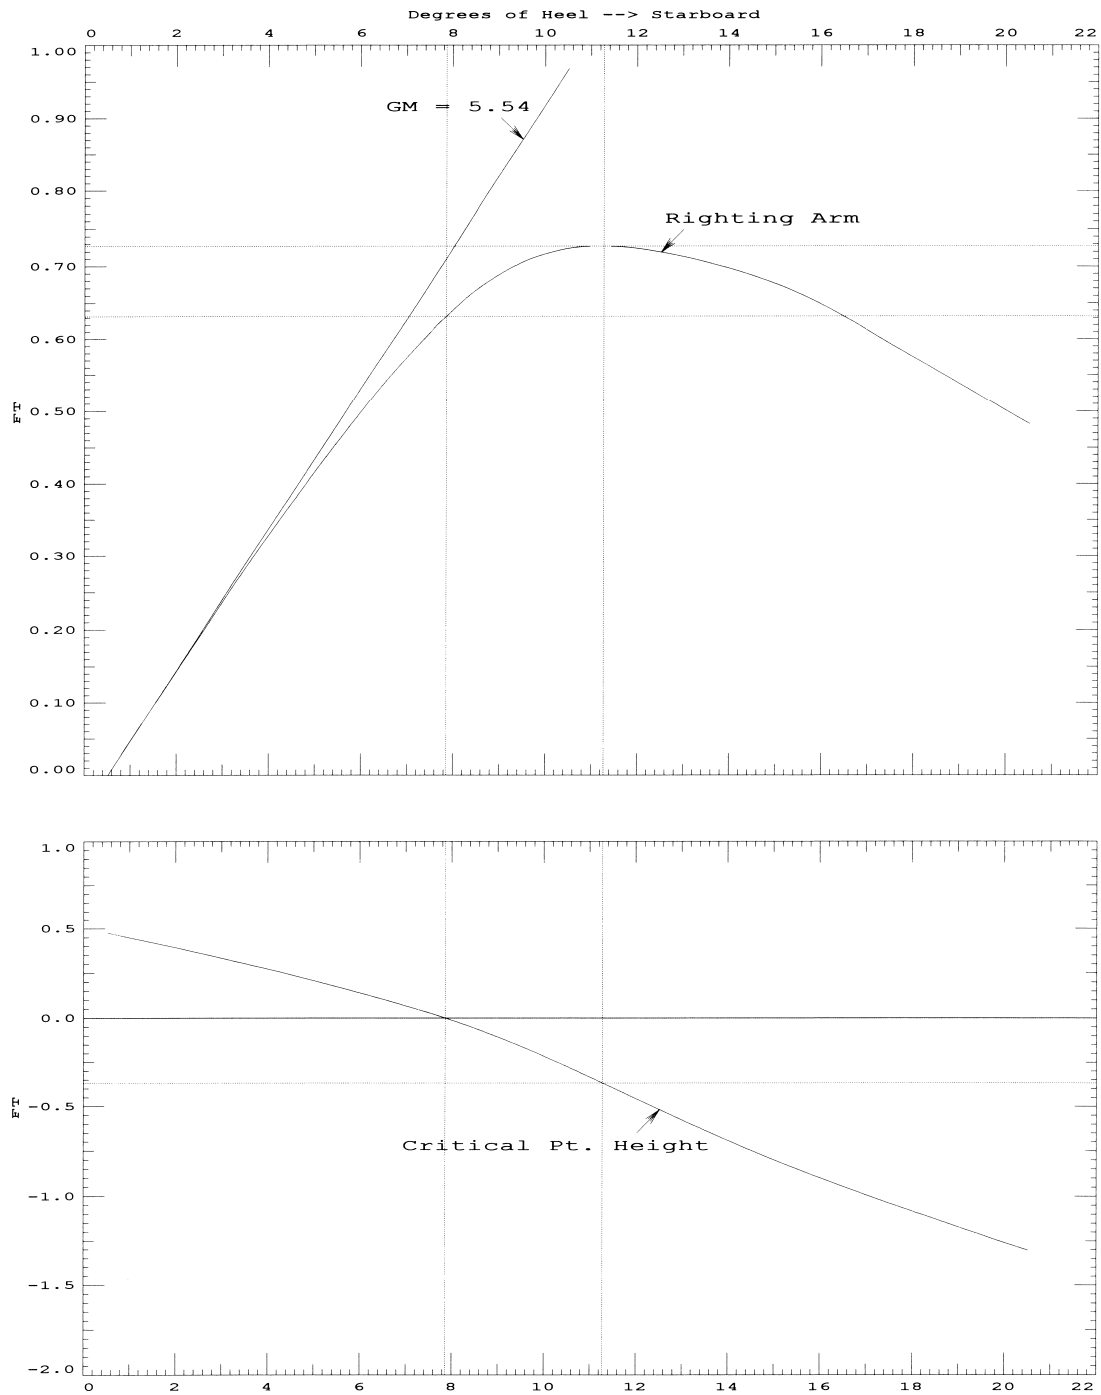
Figure 16 Righting Arm Curve for LADY D

The results of the stability analysis are summarized in Figure 15. What this figure shows is that the LADY D does not satisfy the minimum stability criteria in any of the four tested conditions. In both the extreme starboard and extreme port load conditions the vessels capsizes. Column 4 of Figure 15 shows the final equilibrium heel angle for the vessel in all loading conditions. For both extreme starboard and extreme port loading conditions the vessels heels to about 165 degrees, which is upside down. The 46 CFR 178.340 criteria are irrelevant in these cases since the vessel has rolled over. The CFR requirements in the extreme forward and extreme aft loading conditions are that the top of the pontoon may not be submerged at any location. For the LADY D in both the cases some point of at least one pontoon is submerged. Column 6 of Figure 15 shows the minimum freeboard in each loading condition. A negative freeboard means the top of the pontoon is submerged. In both these loading conditions, the tops of both pontoons were submerged which violates the stability criteria of the CFR. The GHS output for these load conditions are provided in Appendix C.

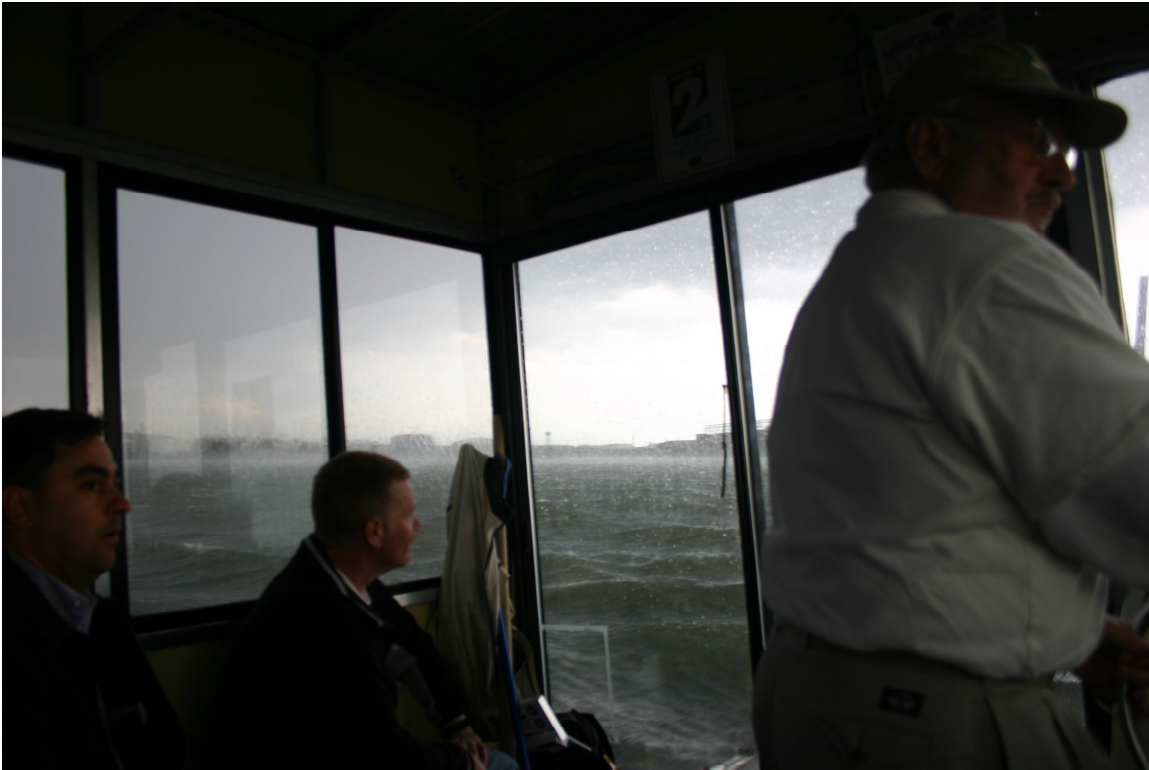
Figure 21 Passenger Photo #3

Passenger photograph #3 taken shortly before capsizing is shown in Figure 21. The location of the LADY D where photograph #3 was taken, approximated by NTSB, is shown as labeled as point 2 on Figure 20. The direction of the photograph is also shown. Photograph #3 was used, along with other information, to estimate wave height, wave period, wave direction, ship heading and ship location at the time of the capsizing.

NTSB provided a photograph of the seas taken from within the LADY D immediately prior to the capsizing. The photograph, designated Photograph #3, was shown above in Figure 21. From this, JJMA estimates the waves to be choppy at about 1 to 1.5 feet with a short period and narrow spectrum. Narrow spectrum describes a short peaky wave rather than a long rolling wave. Witnesses reportedly observed chop of 1 to 1.5 feet. And a theoretical wind generated wave development estimates significant wave height to be 1.25 feet with 3.0-second period.

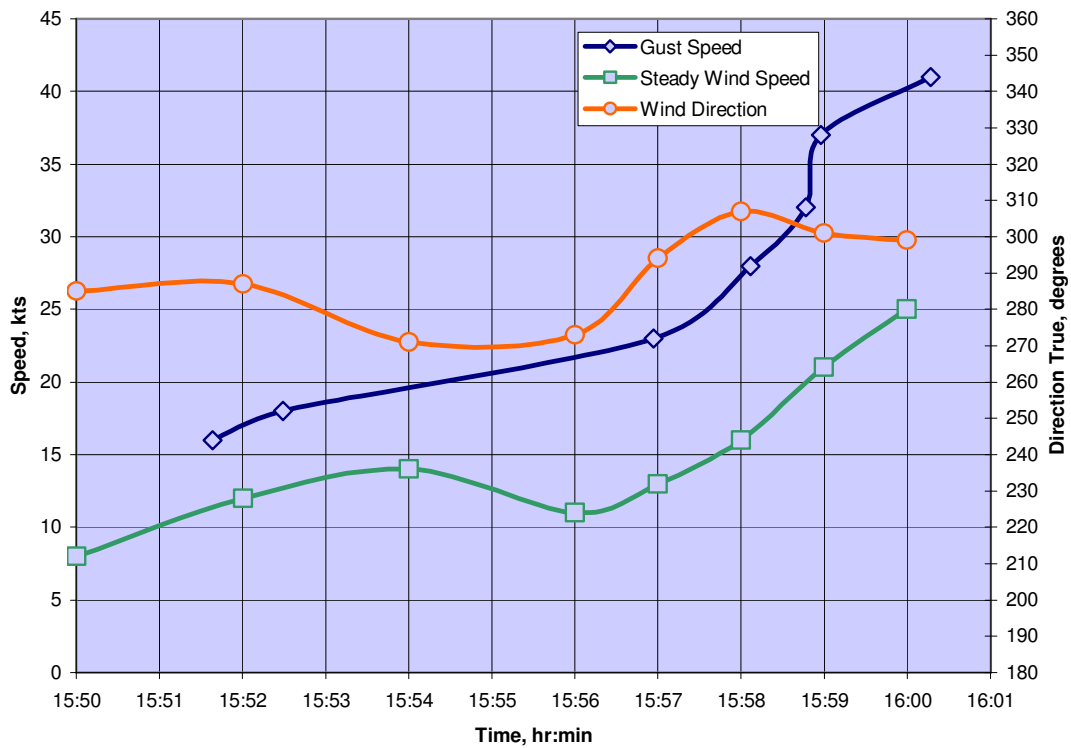
Figure 24 Wind Conditions at BMC March 6, 2004

Steady wind speed, gust speed and wind direction reported at BMC are shown in Figure 24. At the time of the capsizing, 1600 EST, winds were 25 knots with gusts to 41 knots from 300° true.

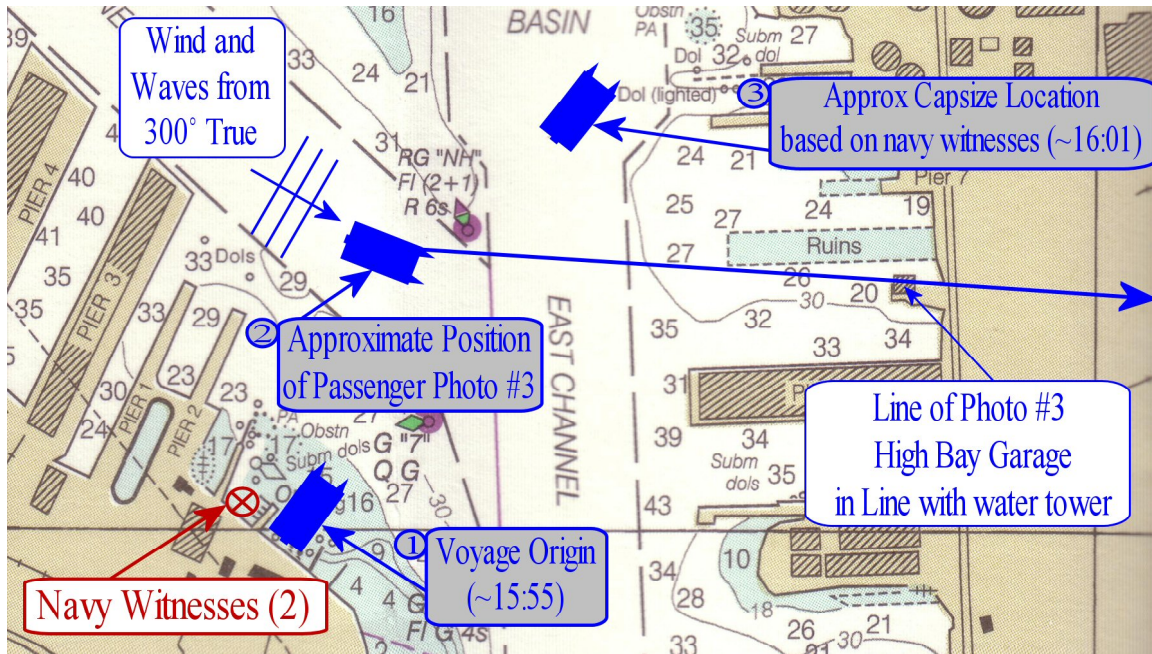
Figure 30 Estimation of Lady D Heading at Passenger Photograph #3

Refer again to passenger photograph #3, Figure 21, it appears that the LADY D is traveling in the direction of the waves. Stern to the seas. The captain, Mr. Deppner, and the front passenger on the port side are visible in photograph #3. The direction of this photograph is approximately due east as shown in Figure 20. Below, in Figure 30, is the estimation of the position of the LADY D relative to wind and waves immediately prior to the capsizing. Witness interviews also confirm that LADY D was running with the waves prior to executing a turn to port. As a final point, wind direction was from about 300° true. This type of wave is wind generated and the wave will run in the direction of the wind.

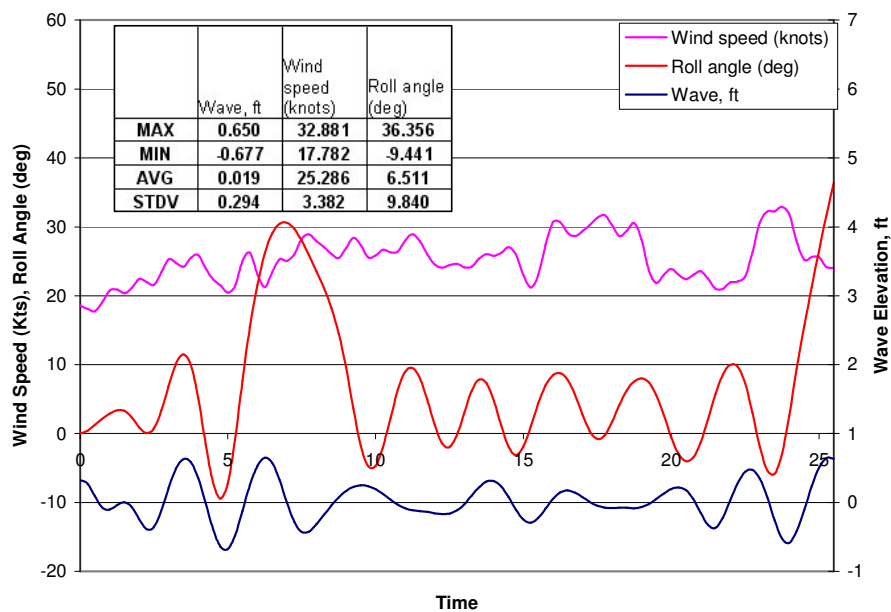
Figure 31 Simulation Time Series Plot for Case #2

The simulations and analysis show that the dynamic effects of wind and waves acting on the LADY D at the time of the capsizing were sufficient to cause capsize. The condition of 1.25 foot wave chop at a peak period of 3.0 seconds and 25 knot steady wind, gusting to 42 knots, aligned to the port beam showed capsize in 100% of 20 simulations. The average time to capsize was 23.7 seconds. The fastest time was 2.5 seconds. All capsizes occurred within 1 minute. All of the simulation run data, statistics and plots are in Appendix E. A sample showing Case #2 is shown in Figure 31.

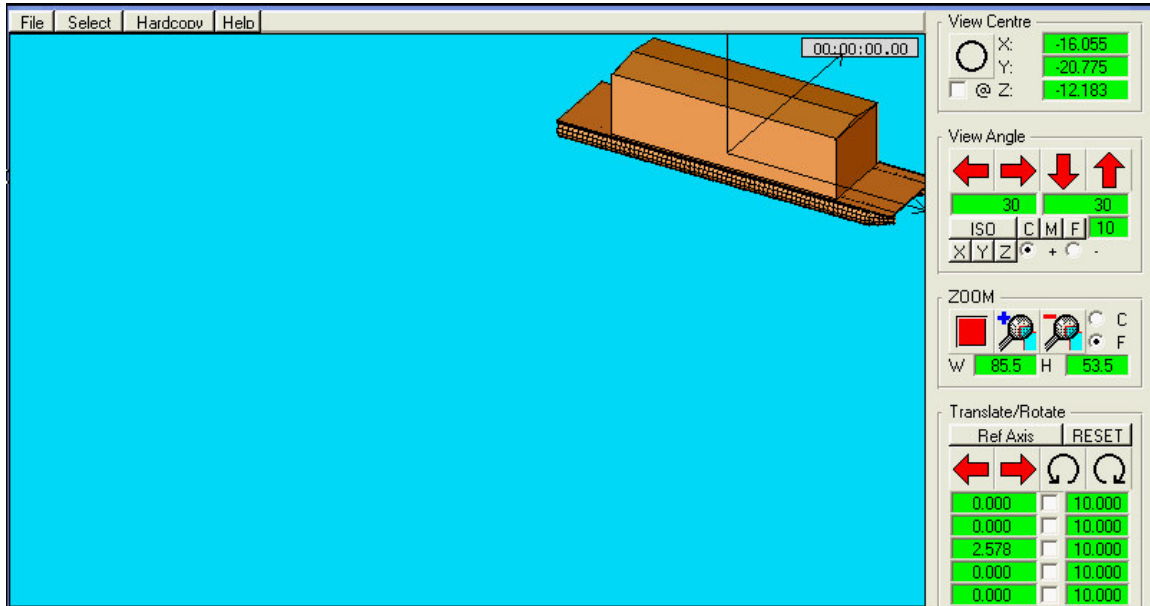
Figure 32 Video Capture of AQWA Case #2

A video of the simulation for Case #2 during which LADY D capsized in 25.5 seconds is presented in Figure 32. As a physics-based engineering simulation rather than a visualization, the AQWA simulation shown does not show the wave field. LADY D is traveling ahead at 5 knots beam to wind and waves. The simulation is stored as Case_2_Simulation_Video.avi on the compact disk included with the report.

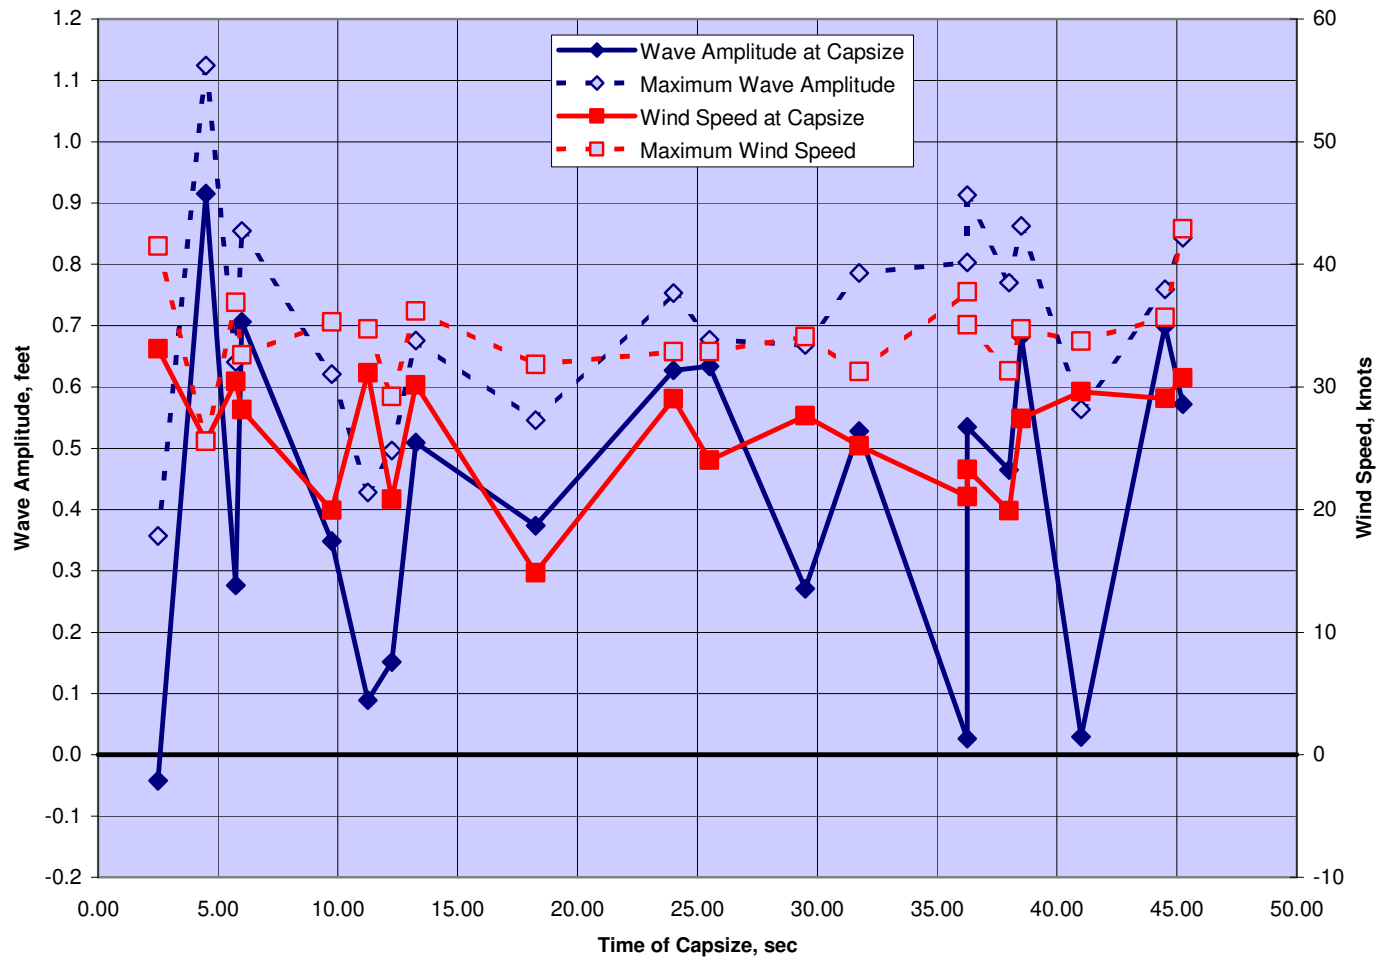
Figure 34 Wave Amplitude and Wind Speed vs. Time to Capsize

Wave amplitude and wind speed vs. exposure time to capsize are plotted in Figure 34. There is no apparent correlation. This implies that no specific combination of simulated wind and waves immediately caused capsize.
